Wood-Fired Boiler System Evaluation at Fort Stewart, GA

Noel L. Potts and Charles M. Schmidt

August 2002

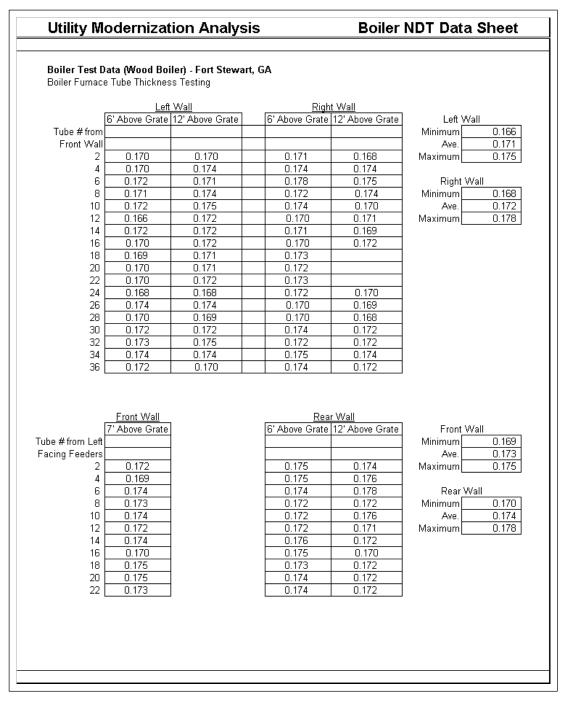
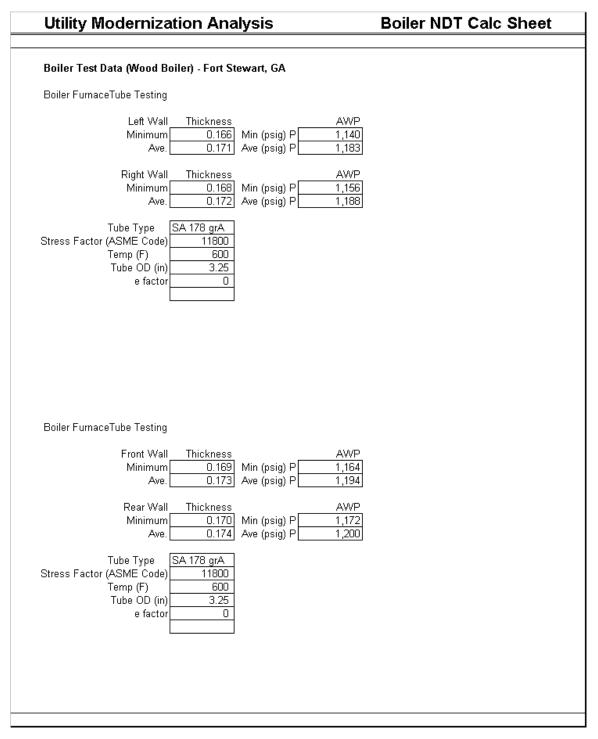
Figure A1. Furnace tube thickness.

The furnace has 122 tubes, specified to have an outside diameter of 3.25 in. and a wall thickness of 0.165 in. There are 39 tubes on each of the left and right walls and 22 tubes on each of the front and rear walls. Ultrasonic thickness testing was conducted on 18 of the left wall tubes and 18 of the right wall tubes at both 6 and 12 ft above the grate. Testing was conducted on 11 of the front wall tubes at 7 ft above the grate and on 11 of the rear wall tubes at both 6 and 12 ft above the grate. Figure A1 (in Appendix A to this report) contain these test results. The left wall tubes had a minimum thickness of 0.166 in. and a maximum thickness of 0.171 in., the right wall tubes had a minimum thickness of 0.168 in. and a maximum thickness of 0.172 in. The front wall tubes had a thickness of 0.174 in.

All of the tubes tested are within manufacturing tolerances and appear to be new. Based upon the ASME code for tubes designated as SA-178 Grade A, the allowable working pressure is over 1000 psig.

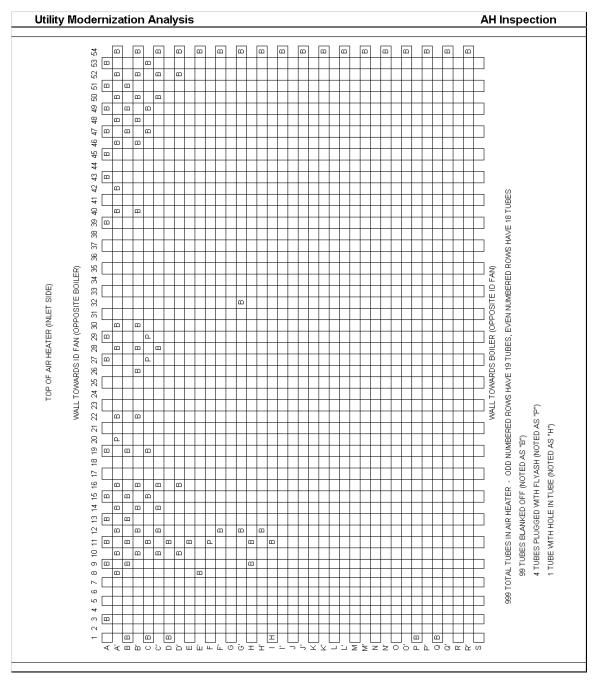
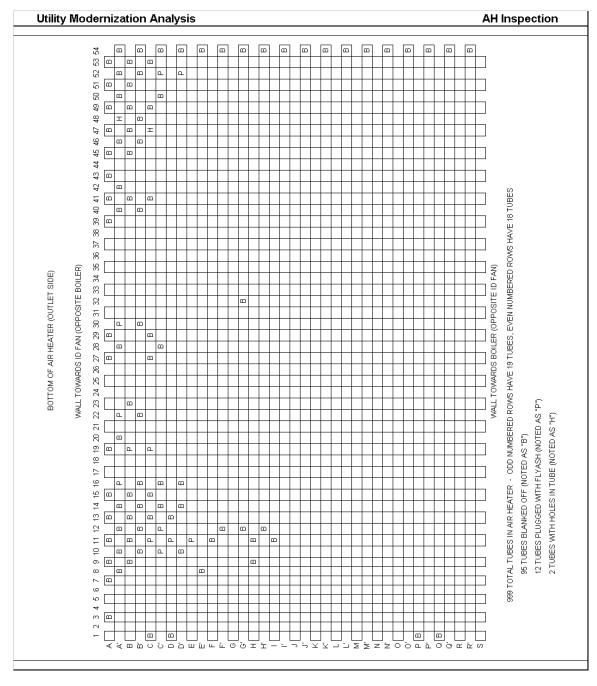
Figure A2. Air-heater inspection data.

The air heater (diagrammed in Figure A2) contains a total of 999 tubes, arranged with 54 rows of tubes across the width of the boiler (from left to right) and 19 tubes per row in the odd numbered rows and 18 tubes per row in the even numbered rows. Tube corrosion is a problem as evidenced by the condition of the tubes. Ninety-nine of the tubes have been mechanically plugged due to holes in the tubes. Another four tubes at the inlet end and twelve at the outlet end are plugged with flyash. There are also three tubes that were found to have holes in them. Leakage in the air heater was confirmed during the on-line boiler evaluation. At the boiler outlet the flue gas oxygen content was measured to average 11.1 percent by volume on a dry basis. At the air heater outlet the flue gas oxygen content had increased to 13.3 percent on a dry volume basis. This was at a

boiler load of 70,000 to 78,000 lb/hr. At lower boiler loads, the oxygen will be even higher. High oxygen levels will cause the carbon in the flyash to begin to glow and eventually burn causing warpage of metal. The hoppers of the mechanical dust collector were replaced due to fires and warpage of the walls. All of the tubes should be replaced.

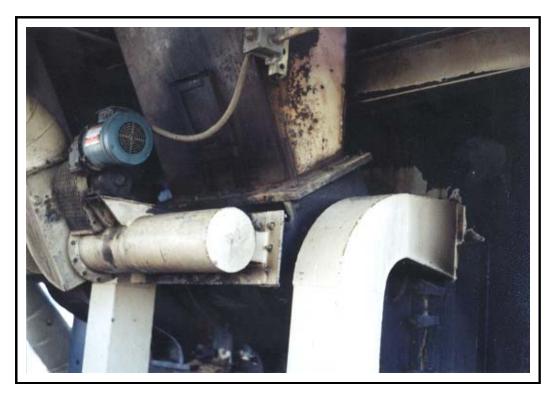
Figure B1. Wood feeder.

Some damage to the front area of the boiler and grate from excessive temperatures is apparent (Figure B1)*. The rear tubes are burnt and need replacing (Figure B2). The damaged areas of the boiler are the insulating trays and the guide supports on the grate. The damage appears to be caused by air entering the boiler through the ash removal system.

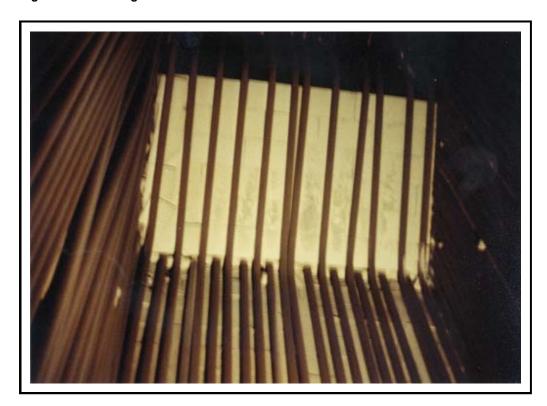
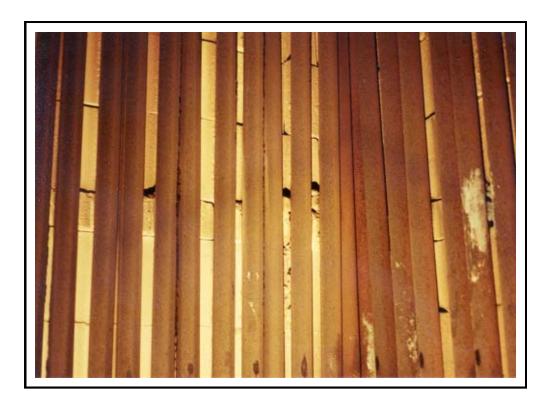
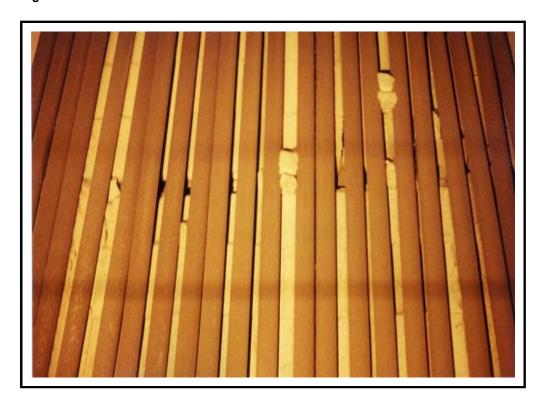
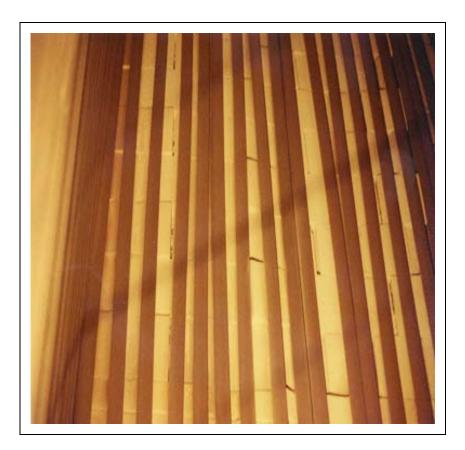
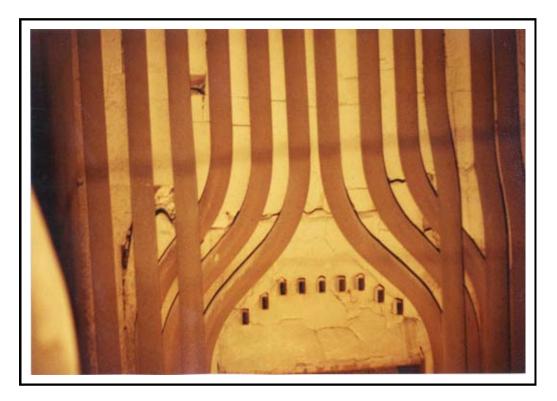
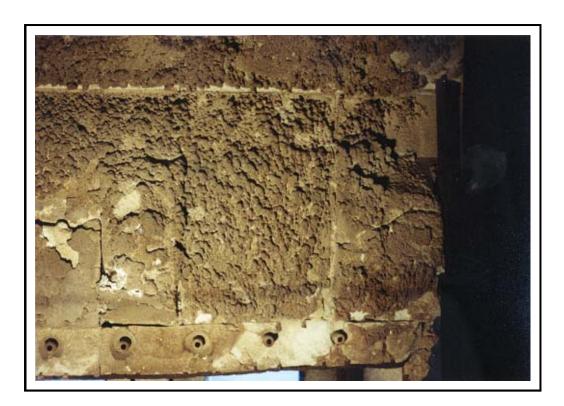
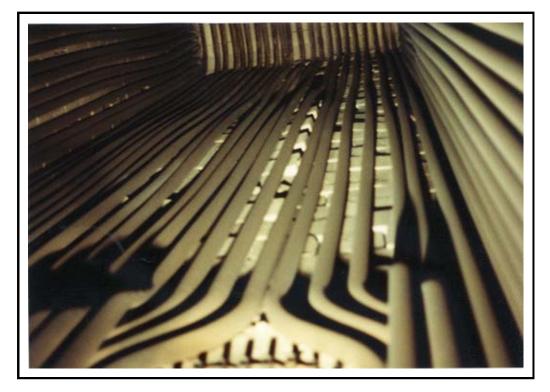
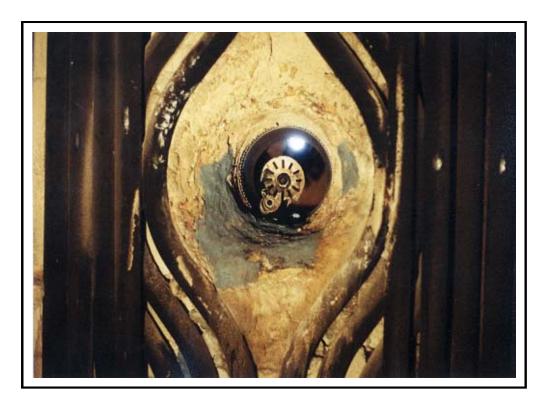
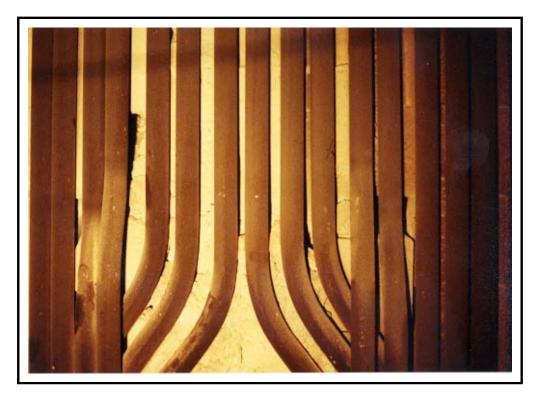
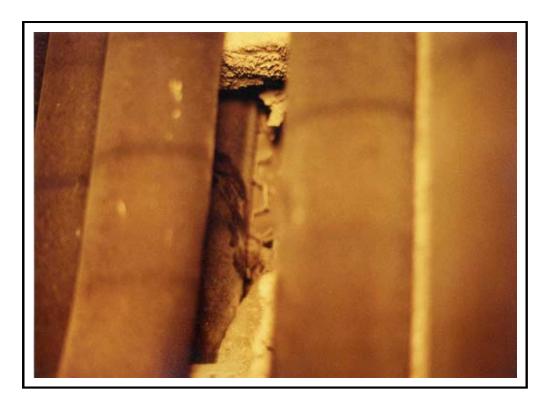
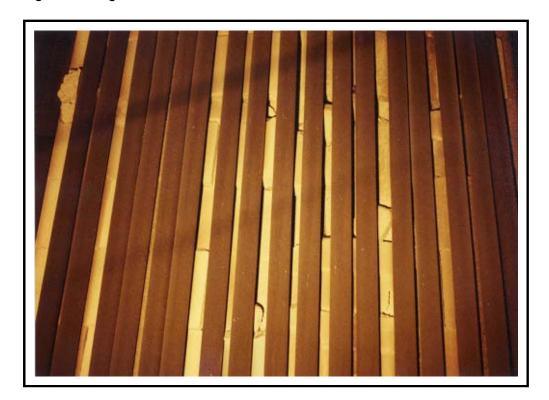
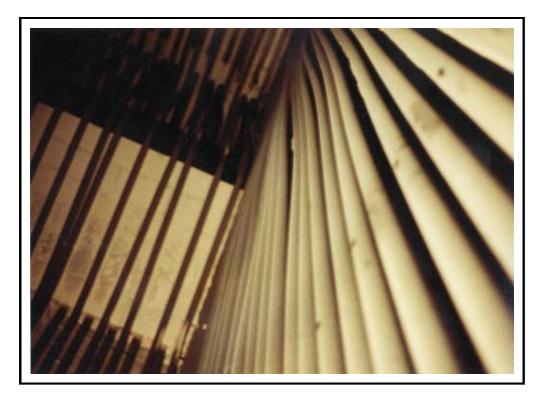
While tube thickness does not appear to be a problem, tube alignment and refractory condition are major problems (Figures B3 to B14). The left and right wall tubes are both bowed approximately 1 to 2 in. towards the middle of the furnace. The bowing starts about 3 ft above the grate and extends up to the top of the bridgewall. The tube misalignment is caused by the condition of the refractory. There are numerous places where the refractory behind the furnace tubes has cracked, moved, and/or fallen out. It is very likely that the tube ties have broken due to deterioration of the refractory, which has allowed the tube ties to be exposed to radiant heat in the furnace. The refractory has fallen out with the opening almost to the outside casing in several places.

The steam boiler and air heater require major repairs to extend the operating life another 20 years. The furnace section of the boiler will require complete removal of the outside casing for complete replacement of the existing firebrick tile, high-temp block insulation, blanket insulation, and tube ties. The standard square edge tile should be replaced with shiplap design tile in an attempt to eliminate the tile movement condition that now exists. Table 3 lists recommended additional boiler and air heater repairs. The total estimated budget price for steam boiler and air heater equipment/construction as described in this paragraph (and Table 3) is \$917,000.

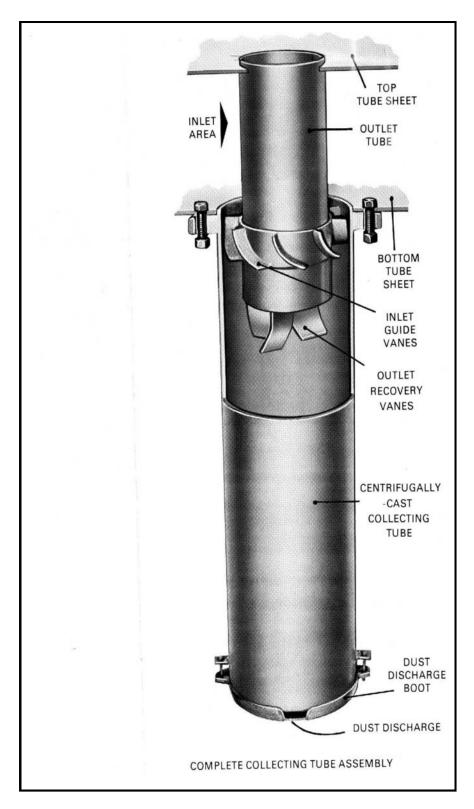
Figure B15. Zurn collector tube.

The mechanical dust collector is a multi-clone type manufactured by Zurn Industries (Figure B15). The unit has a total of 40 tubes arranged 8 rows across the width of the boiler and 5 rows deep. The ash is collected in two hoppers.

The inlet guide vanes are in excellent condition with no scale buildup or broken vanes. The collecting tubes are also in excellent condition with no signs of flyash erosion patterns or holes. The gaskets between the bottom tube sheet and the collecting tube are in good condition with no evidence of leakage. The dust discharge boots at the bottom of the collecting tubes are tight to the tubes but are warped, probably due to fires in the hoppers. These boots should be replaced to ensure optimal collection efficiency. The hoppers have been recently replaced and do not exhibit any signs of leakage. The only other problem found was on the right section of the clean gas tube sheet where there was a ¾-in. hole in the sheet allowing some of the dirty flue gas to bypass the mechanical collector. This hole should be patched.
